CAPSULE SUMMARY  
Cash Lake Dam  
Patuxent National Wildlife Research Refuge  
(PG:64-12)

MARYLAND HISTORICAL TRUST  
MD INVENTORY OF HISTORIC PROPERTIES

Inventory No. PG 64-12

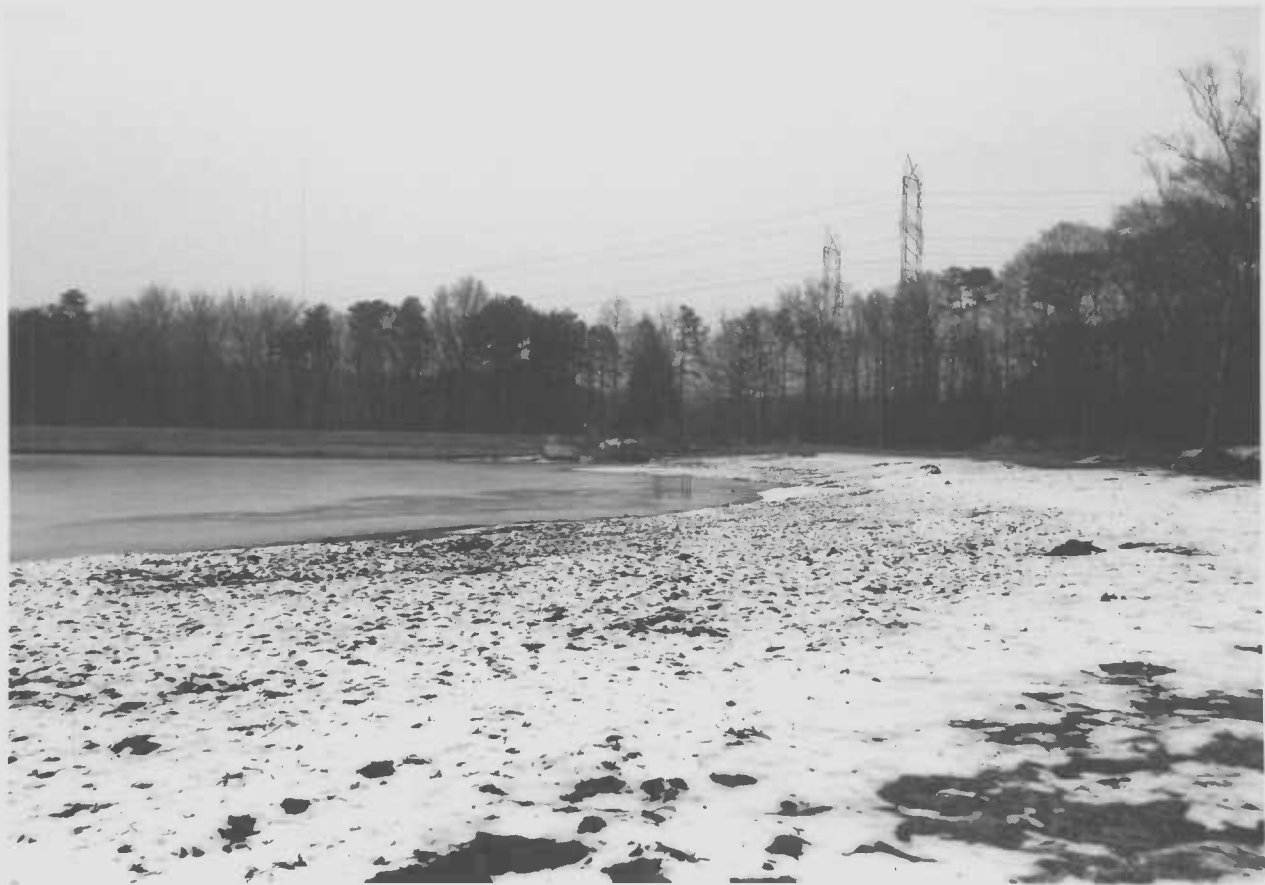
1 OF 14

CASH LAKE DAM, LOOKING NORTHEAST

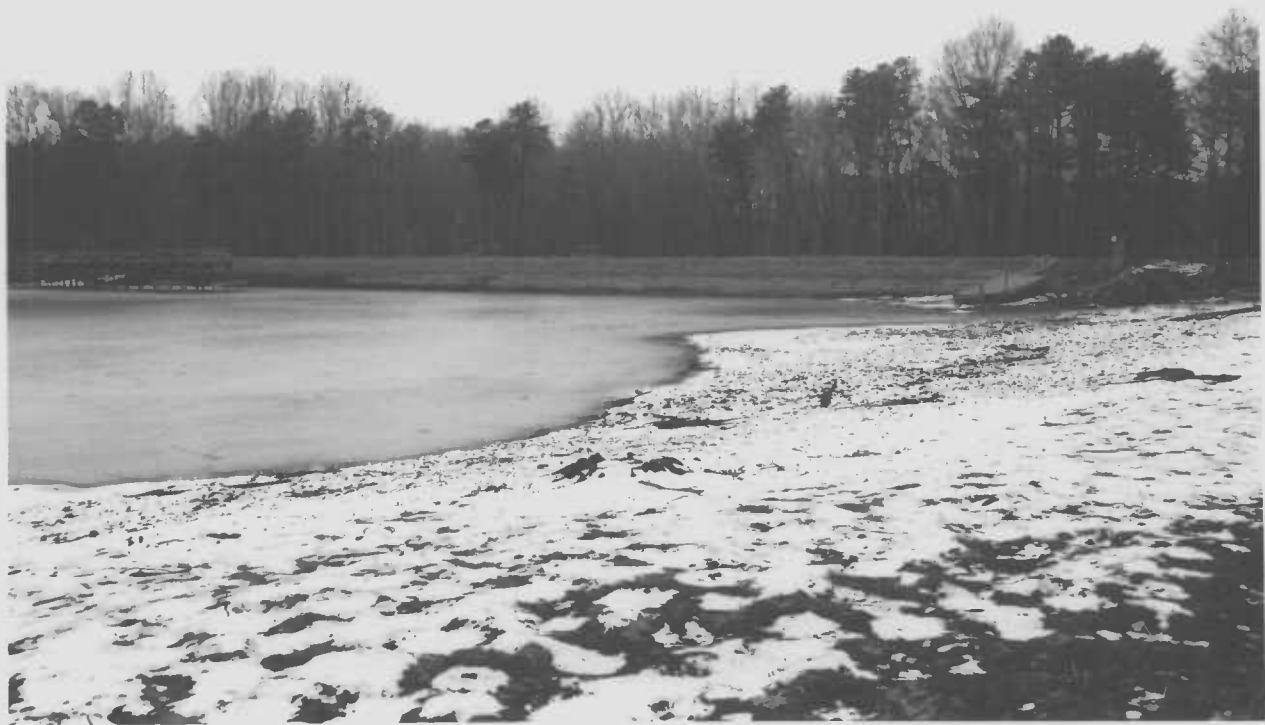
2 OF 14

CASH LAKE DAM, LOOKING NORTHEAST

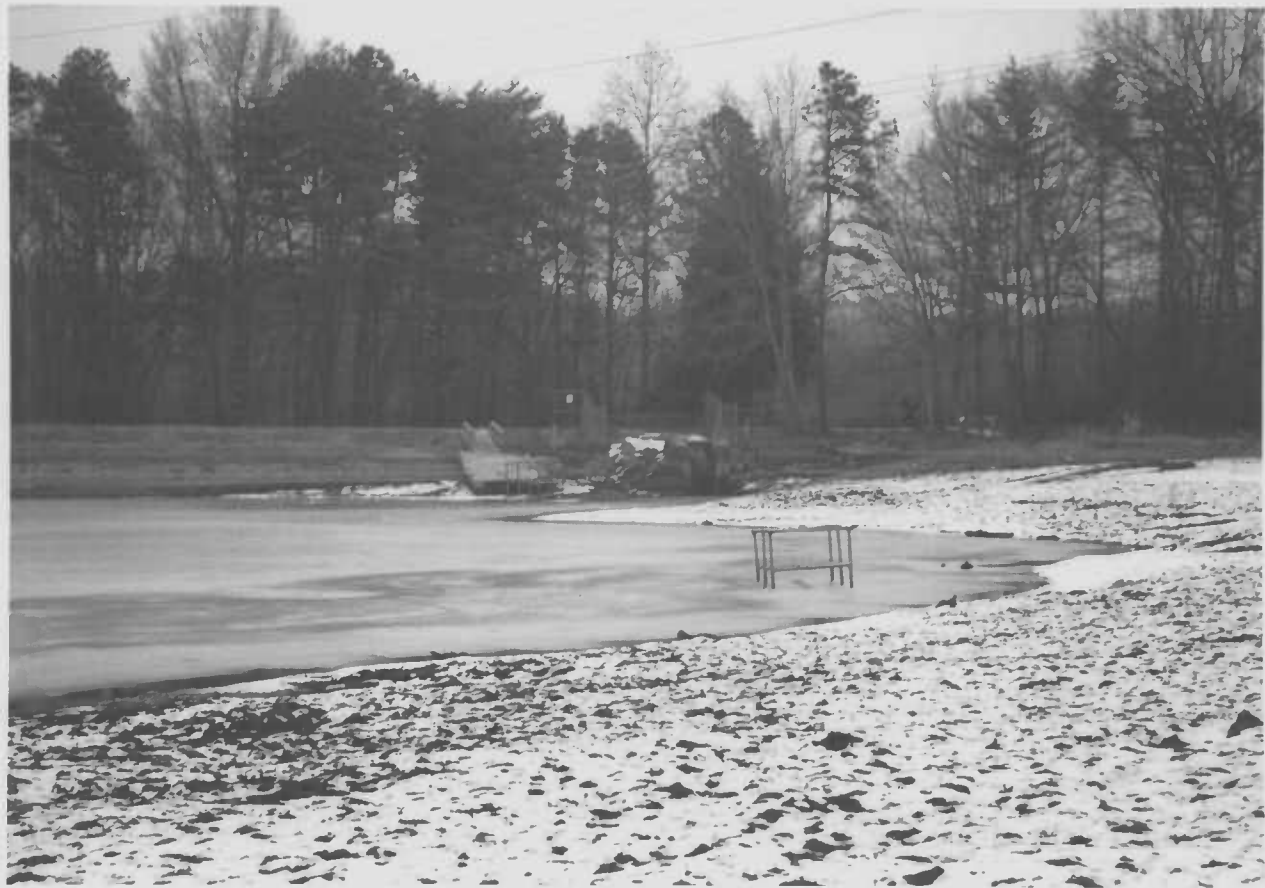
4 OF 14

US FISH & WILDLIFE SERVICE  
CASH LAKE DAM & SPILLWAY, LOOKING NORTHEAST

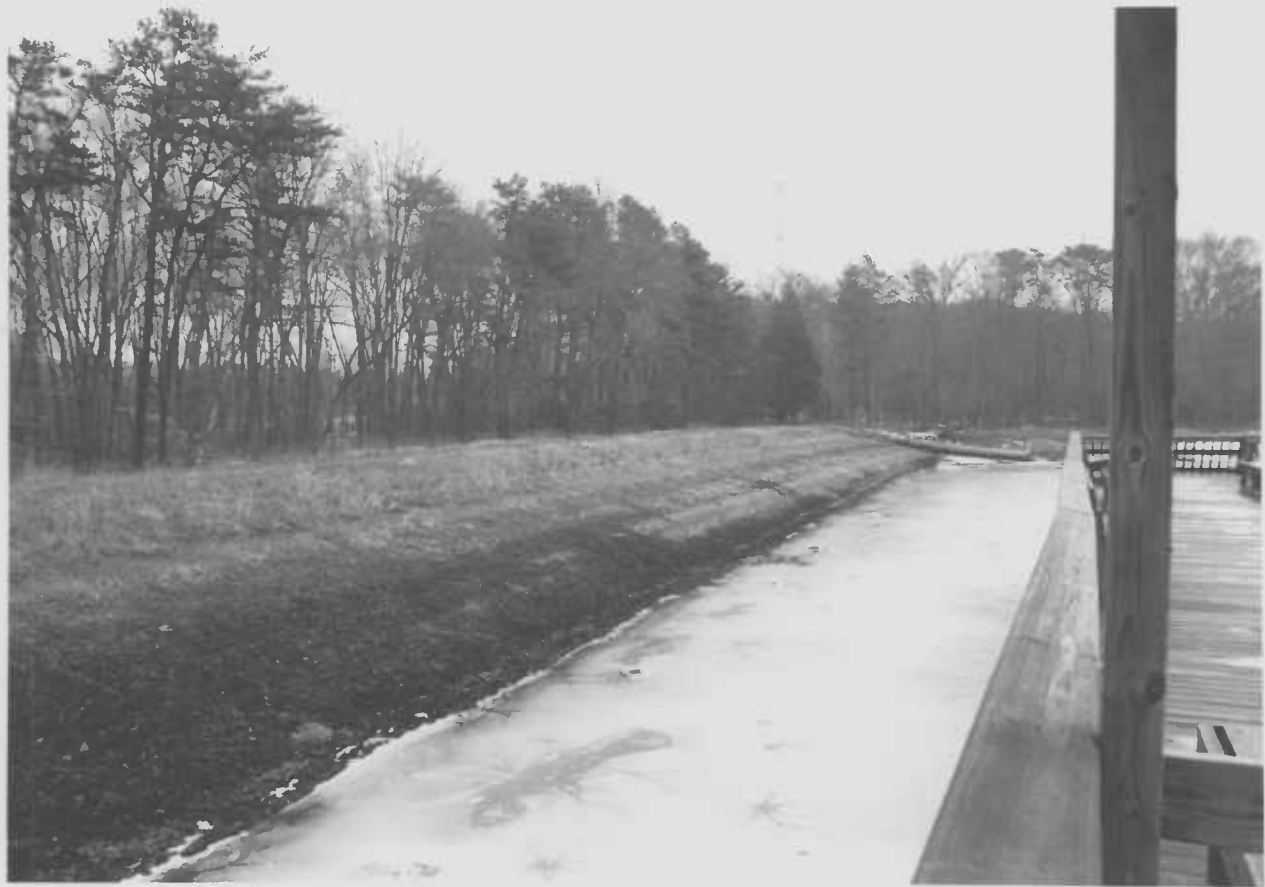
5 OF 14

CASH LAKE DAM, LOOKING SOUTHEAST

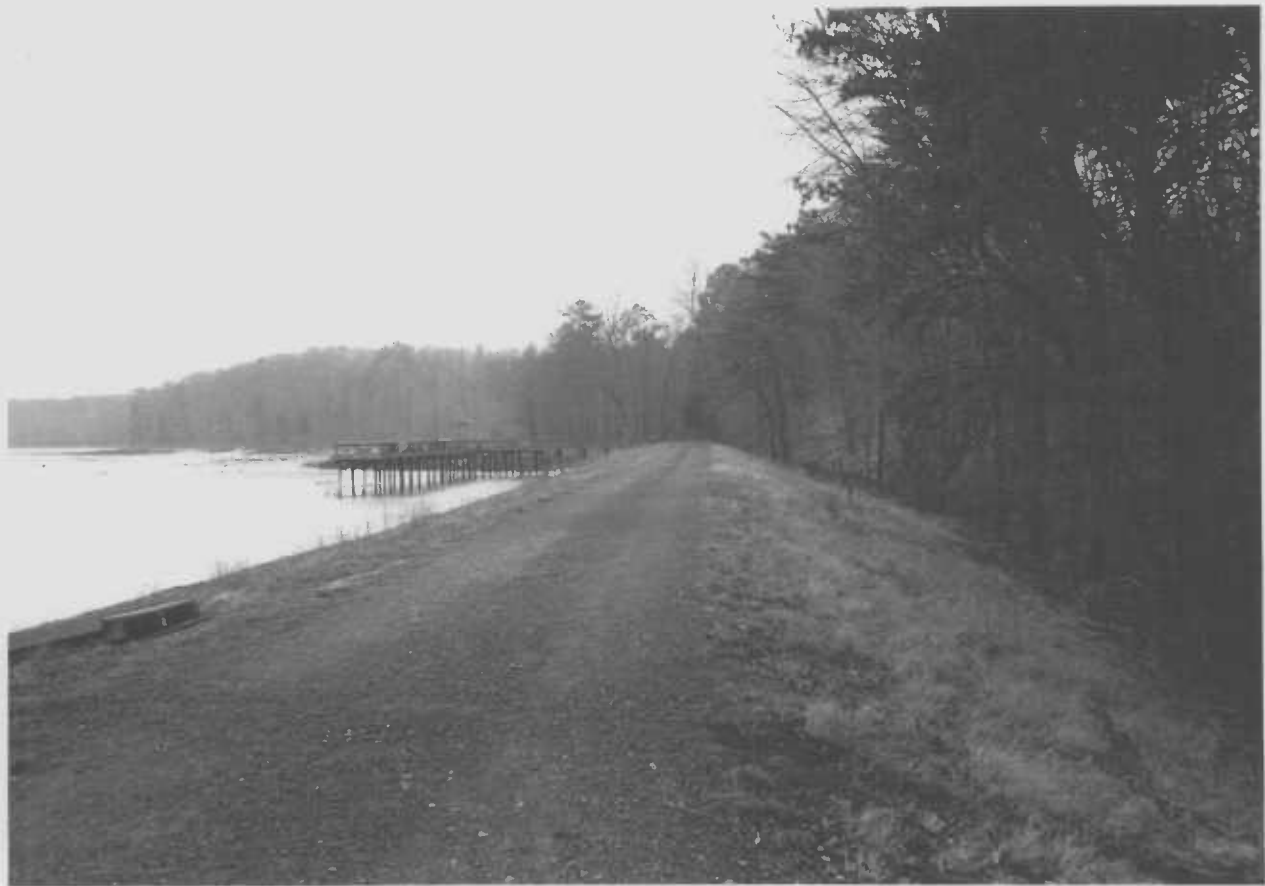
6 OF 14

CASH LAKE DAM, LOOKING NORTHWEST

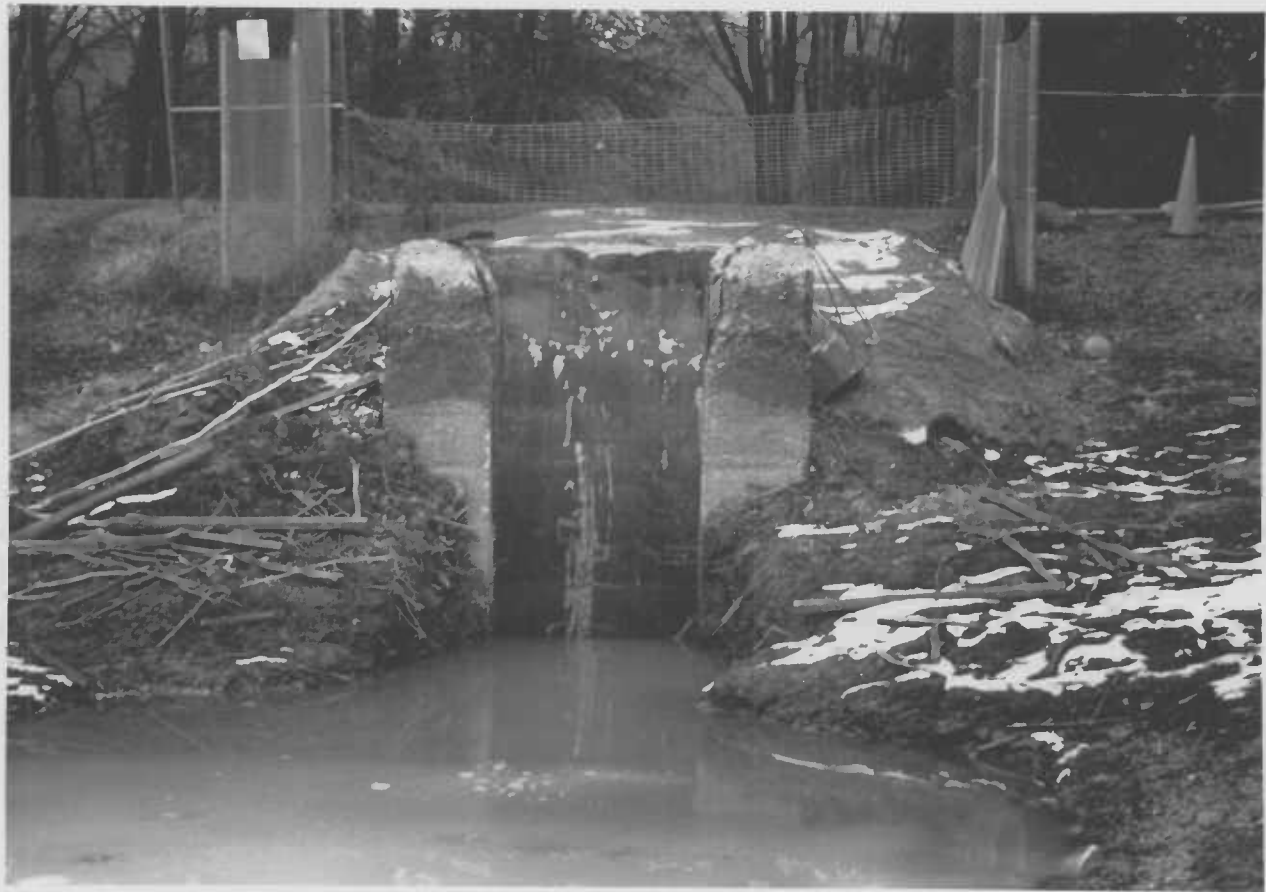
7 OF 14

Lying towards the southeast end of the dam is a reinforced concrete spillway that was also constructed in 1937. The spillway is a necessary element of the structure used to discharge surplus flow, without damaging the dam.<sup>1</sup> The spillway at Cash Lake is U-shaped and measures approximately six feet on each side. The concrete sides of the structure extend upwards from the water's edge. The spillway is constructed of reinforced concrete with a medium sized aggregate. Grooves have been cut into the open side of the spillway, into which wooden plank have been inserted. The wooden planks serve as a small wall over which excess water flows. The outlet of the spillway lies on the opposite side of the dam. It is a small concrete wall that has a low arch through which the water flows.

The face of the spillway has heavy erosion above the waterline. All three sides of the structure exhibit spalling and rusted reinforcement bars are in evidence at the top portions of the walls. Heavy rust

=====  
staining and efflorescence is visible on the sides of the spillway. Portions at the top of the walls have been broken, leaving rough edges and depressions in the surface.

SPILLWAY, LOOKING NORTHEAST

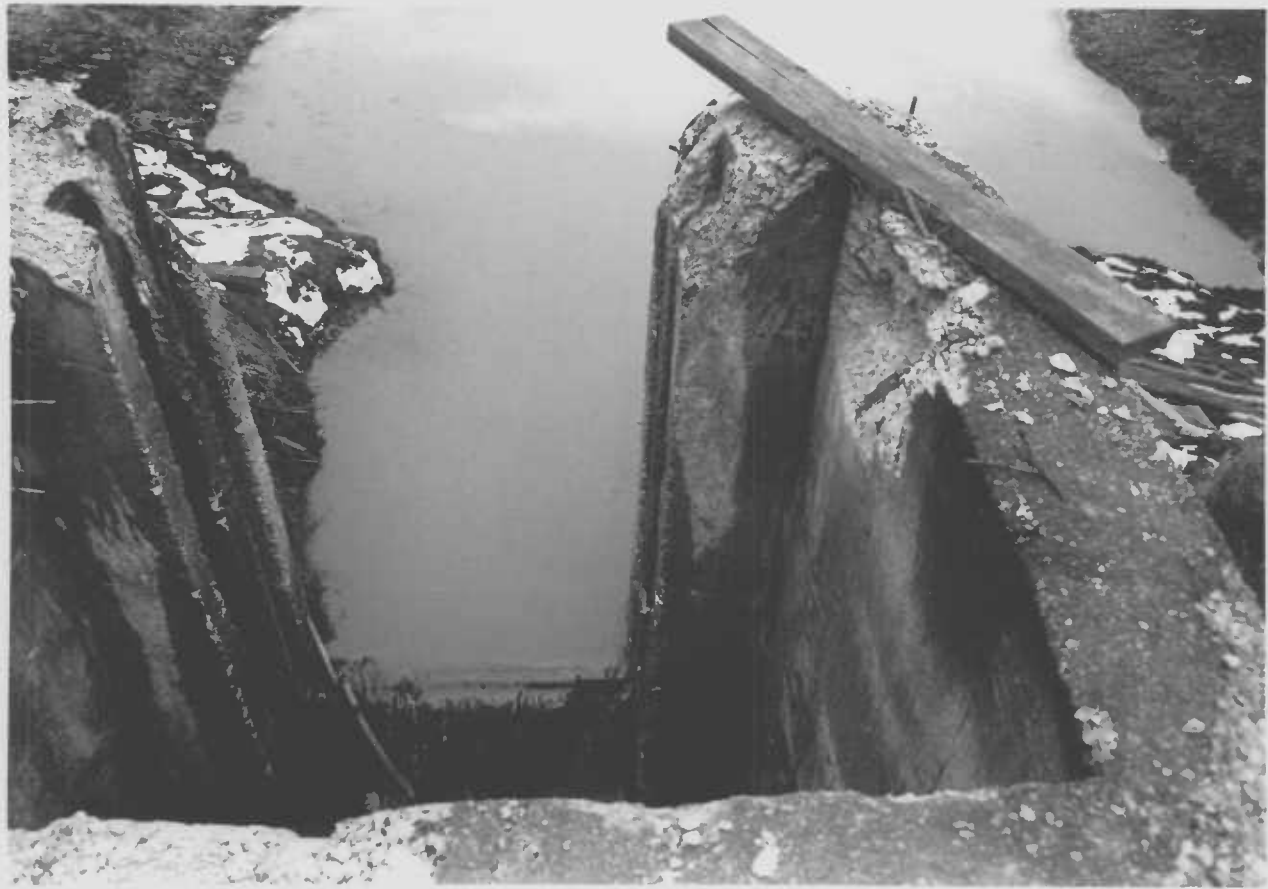
PG:64-12  
CASH LAKE DAM  
PRINCE GEORGE'S COUNTY, MD  
EHT TRACERIES, INC,  
12/98  
US FISH & WILDLIFE SERVICE  
SPILLWAY  
8 OF 14

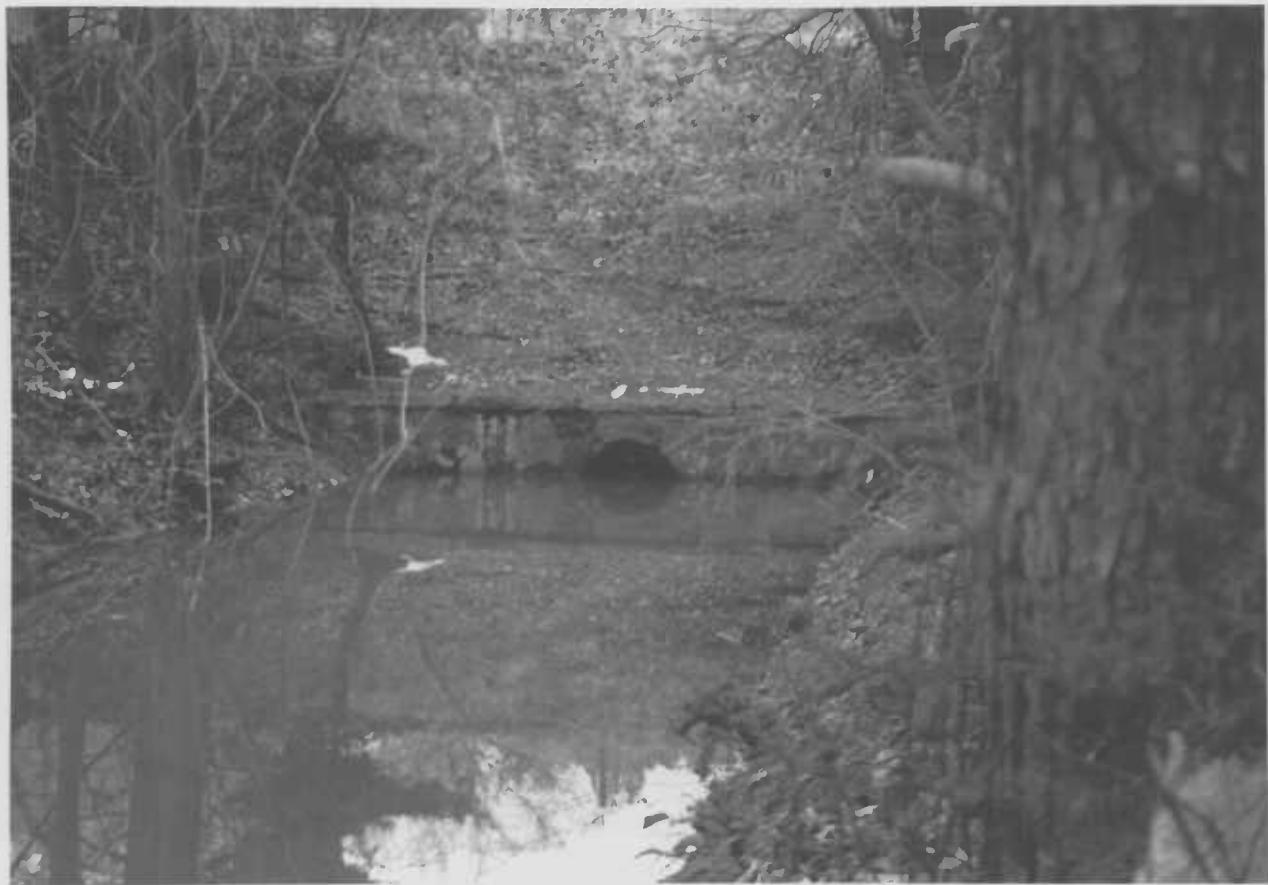
PG: 64-12  
CASH LAKE DAM  
PRINCE GEORGE'S COUNTY, MD  
EHT TRACERIES, INC,  
12/98  
US FISH & WILDLIFE SERVICE  
SPILLWAY OUTLET, LOOKING SOUTHWEST  
9 OF 14

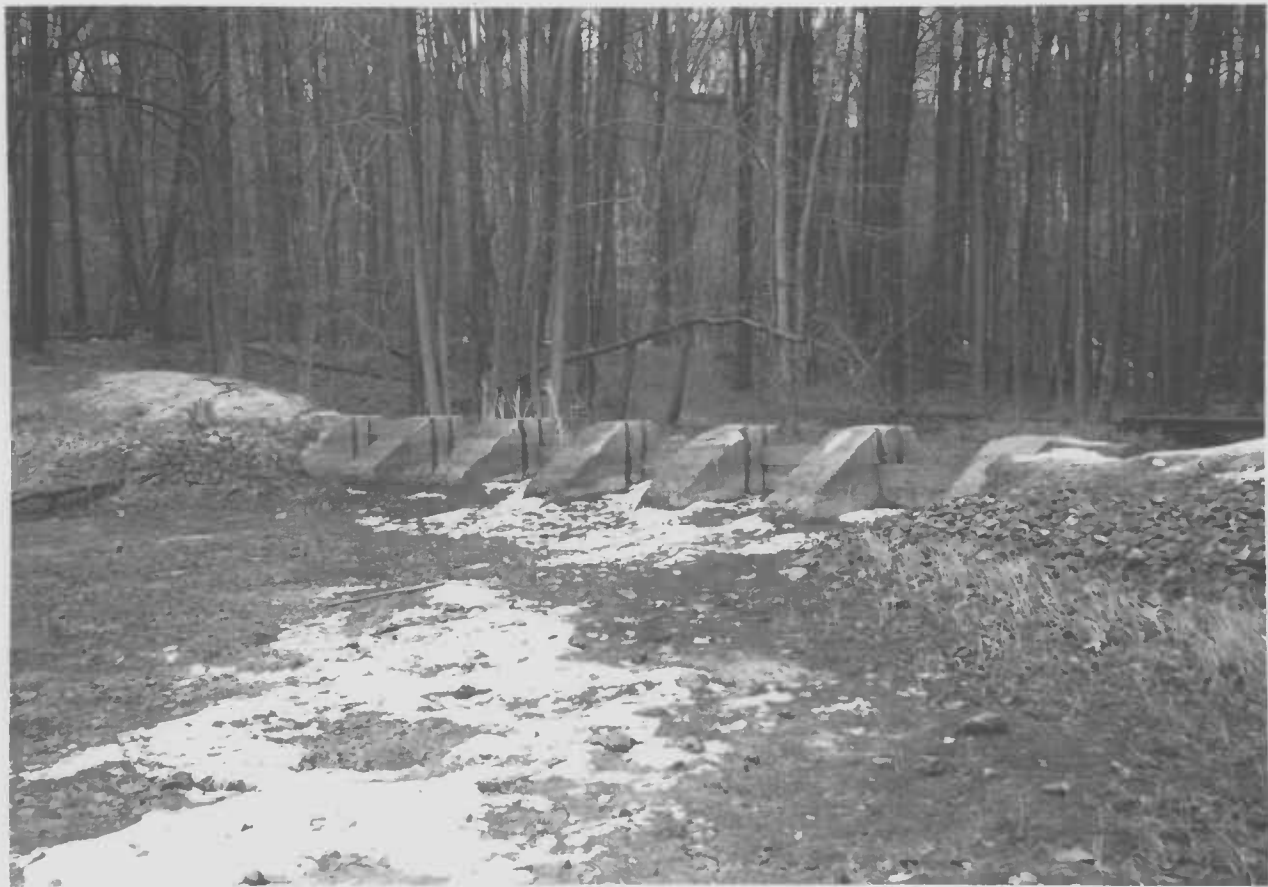
At the opposite end of the dam lies a reinforced concrete and wood sluiceway that was also constructed in 1937. A sluiceway is an artificial channel that is used to regulate or control the flow of excess water.<sup>2</sup> The structure consists of seven trapezoid-shaped blocks that are constructed of a medium sized concrete aggregate. The sides of each block contain two four-and-a-half inch wide grooves into which wood planks have been inserted. These wood planks connect the concrete trapezoids, forming one structure. The concrete blocks stand three feet high and are situated four feet, two inches apart. The slopes of the sluiceway measure three feet nine inches. The brick abutments are covered with parged concrete and there is a smooth transition from the abutments to the end walls of the sluiceway. Cobblestones are laid to the east side of the sluiceway, with woodlands surrounding the north, east, and south sides of the structure.

The sluiceway is beginning to show signs of decay at both the surface and the foundation. The concrete aggregate is eroding and spalling, and heavy rust stains are visible on all sides of the sluiceway. Additionally, the wood planks are beginning to exhibit evidence of decay.

US FISH & WILDLIFE SERVICE  
SLUICeway, LOOKING NORTHEAST  
10 OF 14

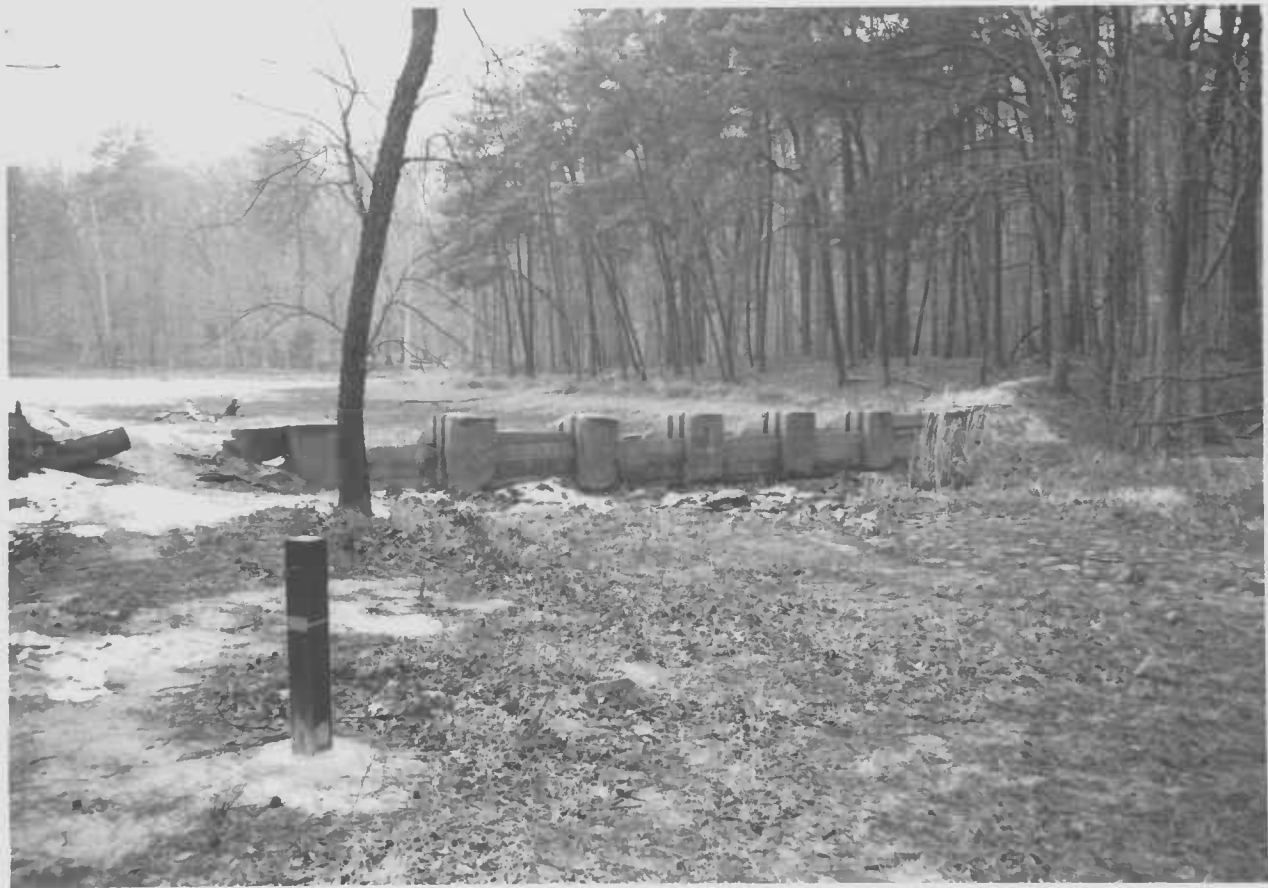
PG: 64-12  
CASH LAKE DAM  
PRINCE GEORGE'S COUNTY, MD  
EHT TRACERIES, INC  
12/98  
U.S. FISH & WILDLIFE SERVICE  
SLUICeway, LOOKING WEST  
11 OF 14
